## PILOT LADDER

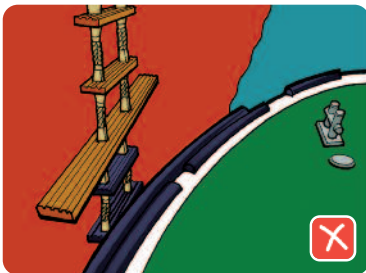
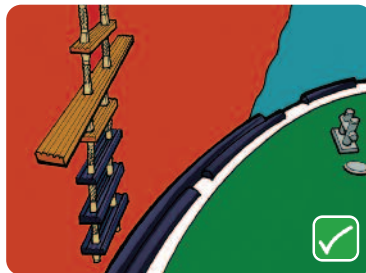
Pilot ladder is rigged too low for the pilot boat. The lower steps are trapped between ship and launch. This could cause pilot ladder to be damaged and/or the ladder ropes to break.

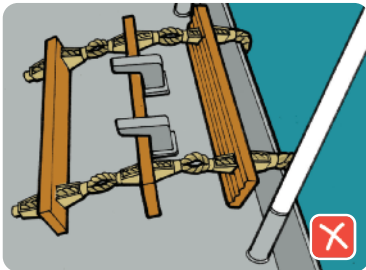
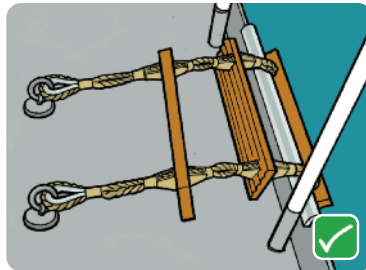
Pilot ladder secured using ship made brackets. The weight of the pilot will be supported by one step only. The hard edge of the top hull plate may damage the ropes.

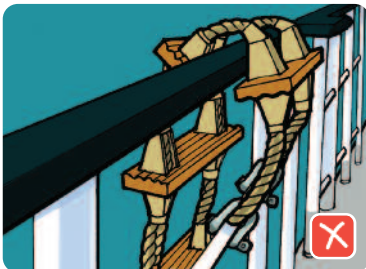
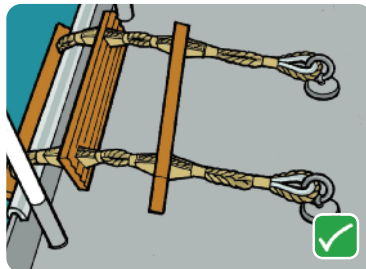
Pilot ladder should not be secured by shackles or tying to ship side rails. These rails are easily damaged and their strength cannot be guaranteed.

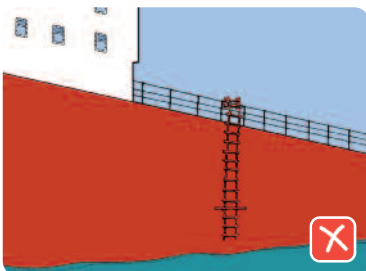
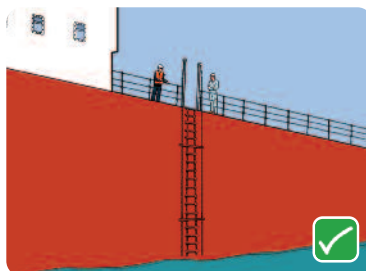
The ladder must be a pilot ladder – constructed with spreaders, correctly rigged in the mid-ships 1/2 section of the ship with safety equipment and responsible officer present in direct communication with the bridge.

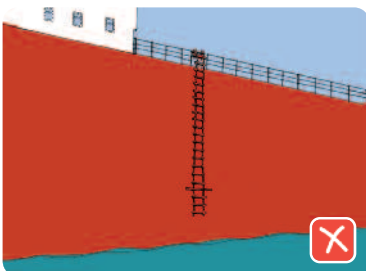
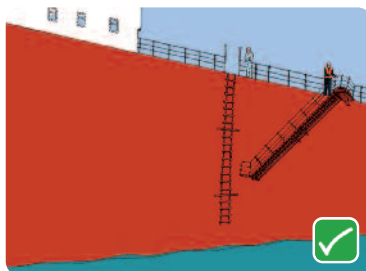
If the distance from waterline to the boarding point is more than 9 metres then a combination arrangement must be used – the accommodation ladder combined with a proper pilot ladder. Check the rules for rigging distances.
