North

Hatch Cover Maintenance

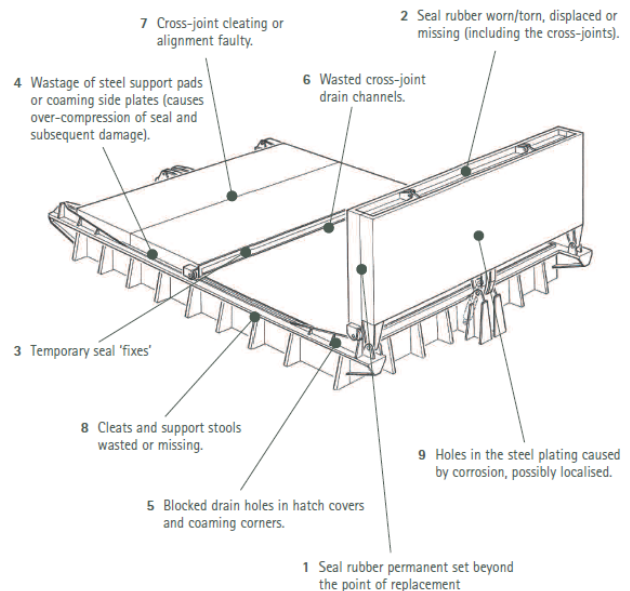
The top ten hatch cover defects giving rise to claims for water damage are shown below. These are based on experience of many hatch cover surveys and damage claims. In most cases, significant claims could have been avoided with low cost preventative remedial work.

- 1) Seal rubber beyond the point of replacement
- 2) Seal rubber worn/torn, displaced or missing (including the cross joints)
- 3) Temporary seal 'fixes'
- 4) Wastage of steel support pads or coaming side plates (causes over-compression of seal and subsequent damage)
- 5) Blocked drain holes in hatch covers and coaming corners
- 6) Wasted cross joint drain channels
- 7) Cross-joint cleating or alignment faulty
- 8) Cleats and support stools wasted or missing
- 9) Holes in the steel plating caused by corrosion, possibly localised
- 10) Wear on the centreline wedge devices on side-rolling covers, which causes the cross-joint to open when the ship is at sea

10 Wear on the centreline wedge devices on side-rolling covers, which causes cross-joint to open when the ship is at sea (not illustrated on above diagram).

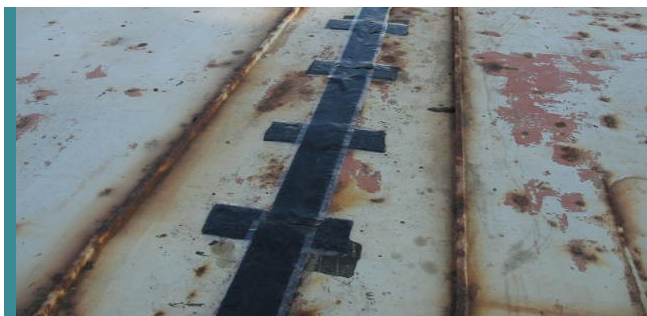
The use of sealing tapes at the cross-joints of hatch covers is common, and is sometimes expressly called for by the shipper or charterer. On the face of it, this seems like a sensible additional precaution to enhance weathertightness. However, there are negative aspects to using hatch cover sealing tape, which include:

- It can lead to a false sense of security
- The tape can wash off in heavy seas
- The tape can obstruct drain holes, trapping water in the cross-joint
- Complete sealing by means of tape is difficult due to the presence of cross-joint cleats or other fittings
- The tape can cause accelerated corrosion of the steelwork due to the deterioration of coatings upon its removal.

Tape or other material should not be used between compression bars and rubber seals as an alternative to proper repairs. Similarly, high-expansion foam is often used as a 'belt and braces' measure to achieve reliable weathertightness. This type of foam is hard to control in practice and can block drain holes and drain channels, such that water leaking in can find its way to the cargo rather than draining out as the system designers intended.

North's policy is that: "the use of such tape or foam is acceptable as an additional precaution on well-maintained weathertight hatch covers, but is not acceptable as an alternative to proper permanent repairs".

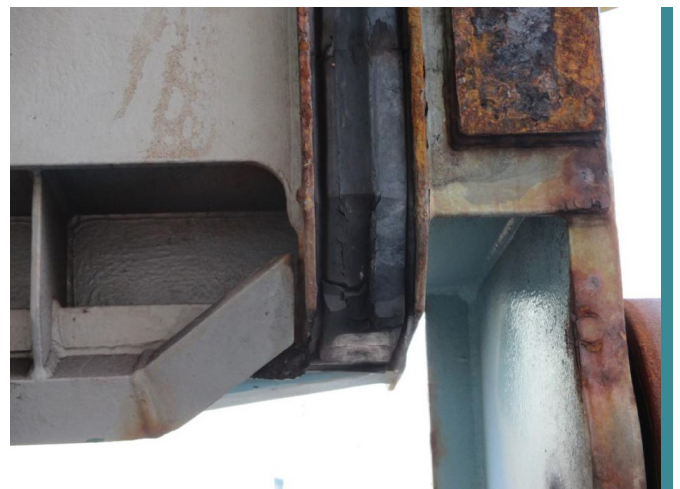
Rubber seals on well-maintained hatch covers can normally be expected to last several years in normal service. However, if the seal is over-compressed due to deterioration of the hatch cover steel work, bearing pad wear or misalignment of the hatch cover panels, the seal will undoubtedly become damaged. This damage may be tearing of the rubber seal or detachment of the seal from its retaining channel, whereby it is easy to see that an immediate repair is required.

More commonly, the over-compression causes the elasticity of the seal to be lost resulting in a deep groove in the rubber known as 'permanent set' (see photograph). It is quite easy to measure the depth of the permanent set using a ruler or a gauge. This should then be compared to the designed compression of the seal, found in the onboard hatch cover operating and maintenance manual).

Manufacturers state that: "when permanent set reaches half the design compression - replace the seal".
