Signals

NEWSLETTER

Issue 97: October 2014

LOSS PREVENTION NEWSLETTER
FOR NORTH'S MEMBERS

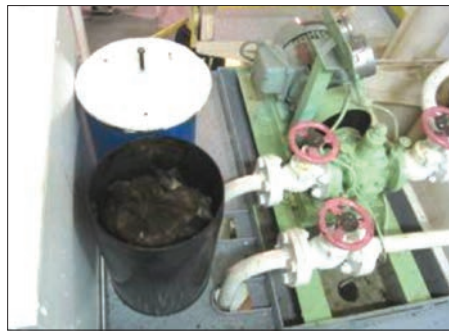
Rag bin with missing lid – a potential fire risk.

It is recommended that types of garbage that could present a hazard to the ship or the crew, such as oily rags, be separated at source and kept segregated. Due to the additional fire risk, it is further recommended that oily rags are kept in a closed fire-resistant receptacle and this should be reflected in the vessel's garbage management plan.

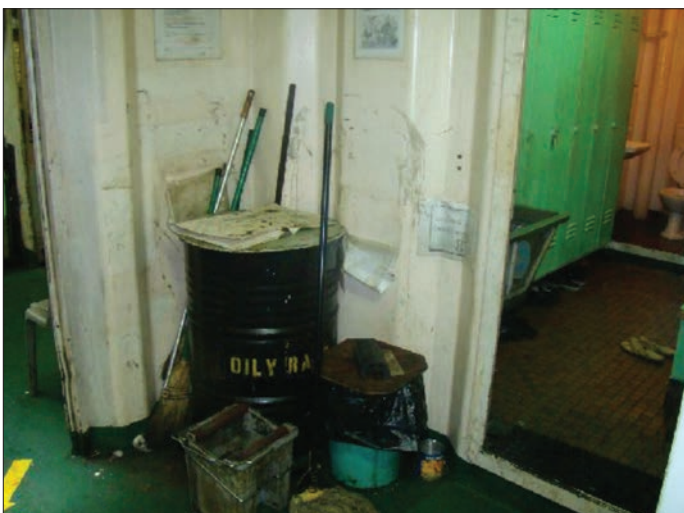
An untidy garbage station – a potential fire risk.

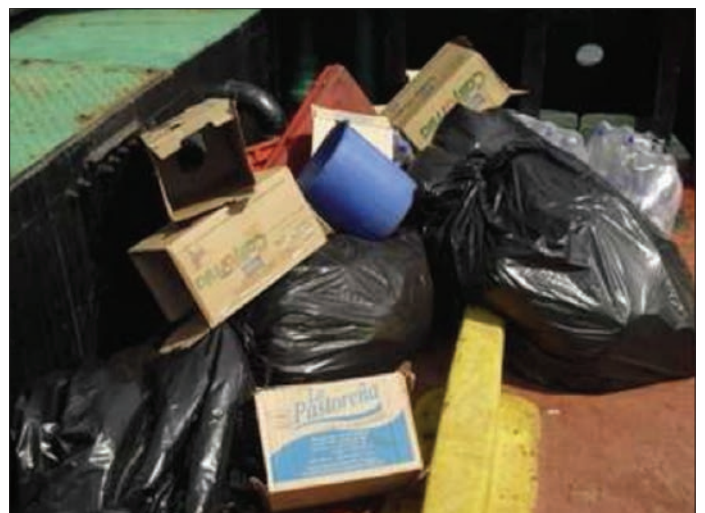
Untidy storage on deck may lead to pollution.

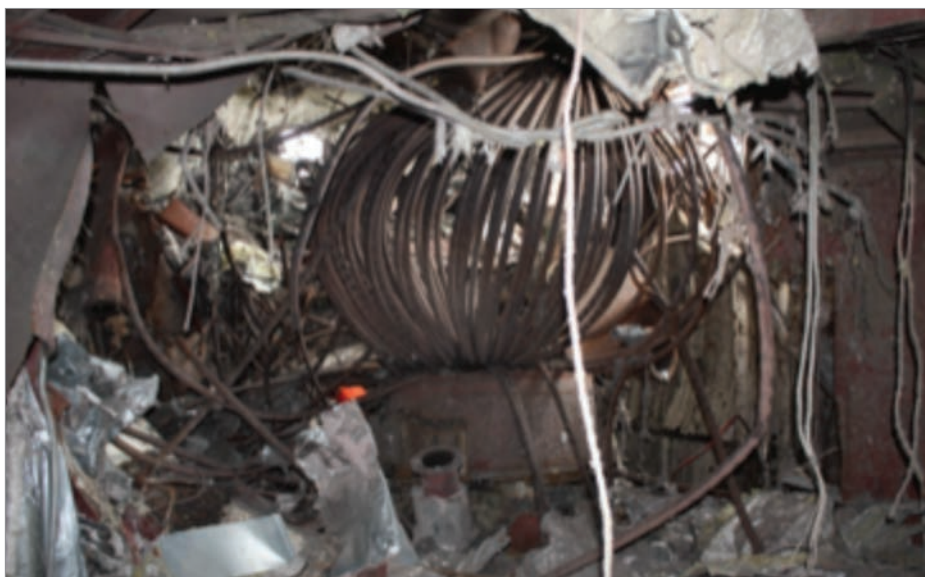
Explosions can occur in the boiler furnace and this is more commonly known as furnace blowback. An excess of unburnt fuel accumulates in the furnace and when it finally ignites, the combustion is uncontrollable and a violent explosion can ensue.

There are a number of reasons why this can happen and care should be taken to avoid these circumstances during operation. The most common are:

- Leaking or poorly maintained burner units – either allowing the introduction of excess fuel during operation or allowing fuel to pass through when the unit is shut down.

- From repeated failed attempts to fire the boiler and without sufficient purging between attempts. This could potentially occur when attempting to set up the clearances of the burner ignition electrodes. Most boilers will have an automatic starting sequence which incorporates the minimum safe purge time, but this can be bypassed when operating in manual mode.

- Flame failure safety device not functioning – the boiler will be fitted with a safety device consisting of a 'magic eye' photoelectric sensor, the purpose of which is to sense when the flame in the furnace has been extinguished and then automatically shuts off the fuel supply. If this safety feature is malfunctioning, then fuel may continue to be introduced into the furnace despite there being no ignition.

The aftermath of a boiler explosion.

A properly implemented planned maintenance system, vigilant monitoring of the boiler water and feed water condition (including feed make-up) as well as adherence to safe operating procedures will significantly reduce the risk of a boiler explosion.
