Checklist

HATCH COVER

Use with North's loss prevention guide – Hatch Cover Maintenance and Operation – and Maker's Manual. Always refer to hatch cover Makers for specific advice on repairs.

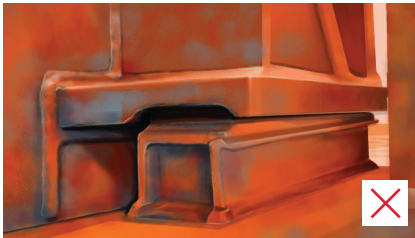
Bearing pad - no support

Worn out bearing pads cause panel steel to steel contact and over compressed rubber seals. Always check the bearing pads are in contact and providing correct support and rubber seal compression.

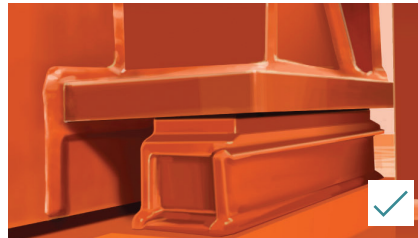
Bearing pad - correct support

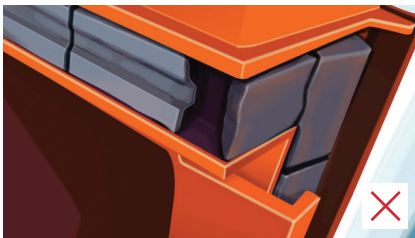
Rubber seal - corner made up

Always use the correct materials and spares as recommended in Maker's Manual. Are there sufficient spares on board including spare cleats and rubber washers, pre-formed rubber seal corners, and linear rubber seal? Corner pieces should not be made up by splicing pieces of linear rubber seal.

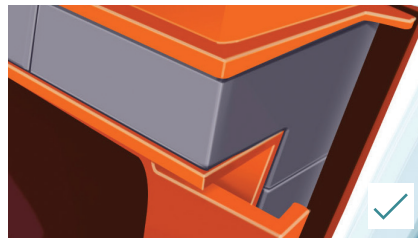
Rubber seal - corner pre-formed

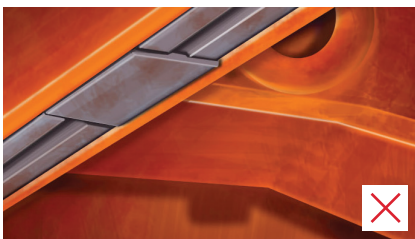
Rubber seals - short inserts

Never use short inserts to make up gaps in linear rubber seals. In practice the minimum length of any insert should be about 1 metre, with an absolute minimum of 50 centimetres.

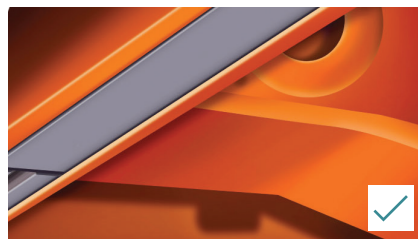
Rubber seals - min. insert 50cm

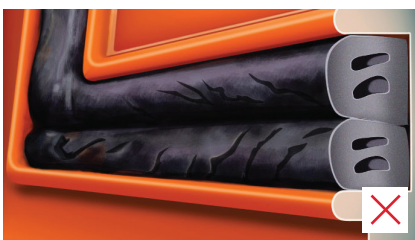
Rubber seals - permanent set

Do not try to correct permanent set in rubber seals by inserting another seal underneath. Always replace with new when the permanent set reaches half of the designed compression.

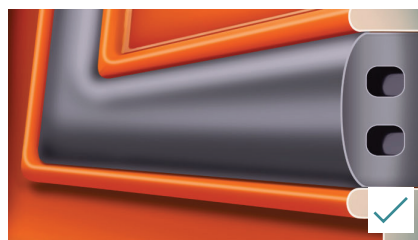
Rubber seals - good compression

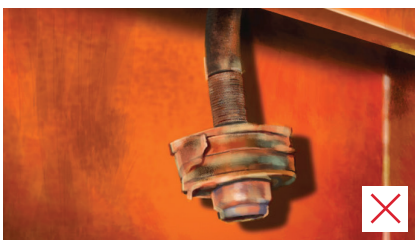
Cleat - damaged washer

Seized and/or rusty cleats with damaged rubber washers, more than one rubber washer, or bent rods must be replaced. Regularly inspect the cleats and replace rubber washers with one correct spare when necessary.

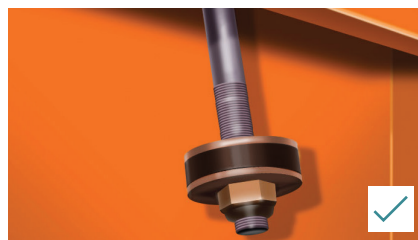
Cleat - washer in good condition
